# Braddock Bay Restoration

## 2016 Monitoring and Adaptive Management Report

U.S. Army Corps of Engineers

3/15/2017

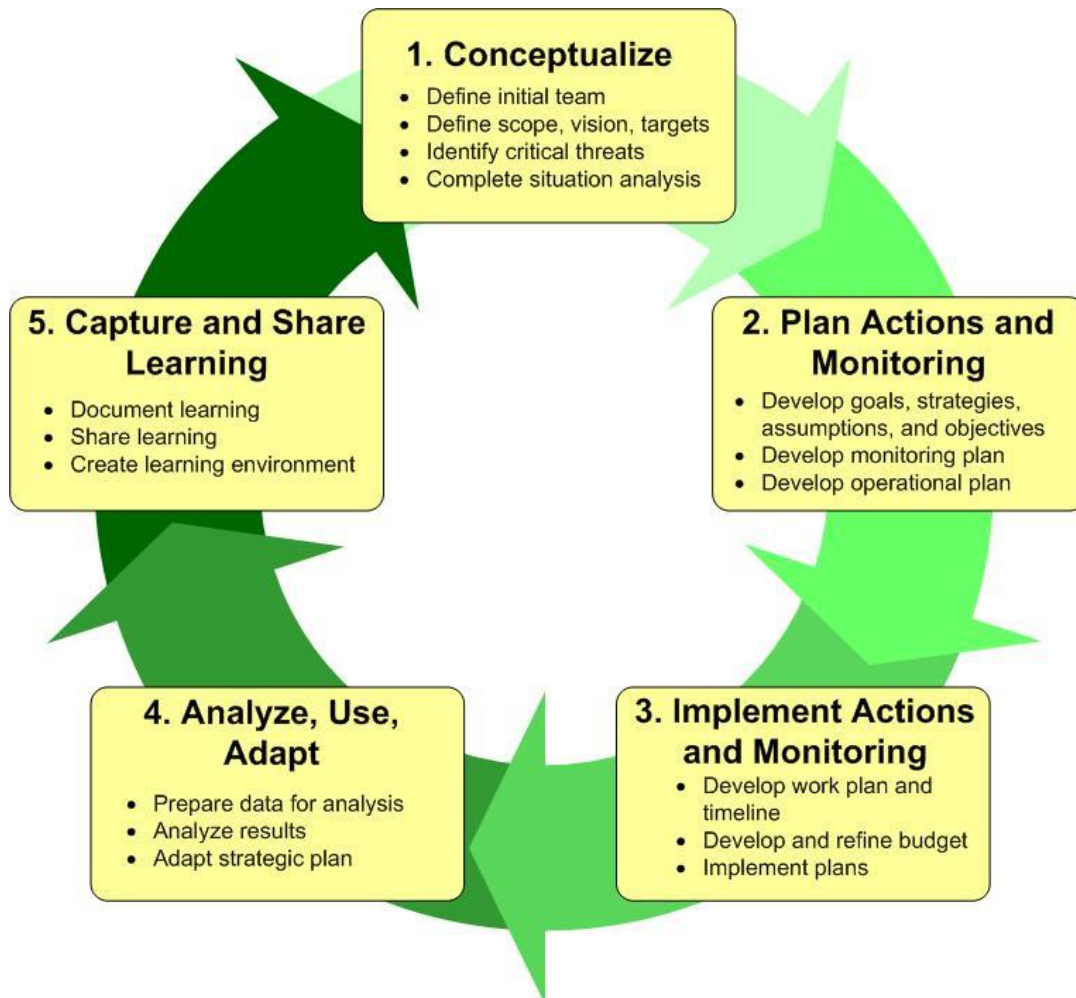
Figure 1. Adaptive management steps from New York's Great Lakes action agenda.

1. **Conceptualize the problem** by defining the scope, vision, targets and complete situation analysis;

2. **Plan Actions and Monitoring** through development of goals strategies and assumptions. Develop an operation and monitoring plan;
3. **Implement** the Actions and Monitoring by developing a work plan and timeline;
4. **Analyze Use and Adapt the plan** through analysis of the data, and change the plan if necessary to achieve the stated goals and objectives; and
5. **Share the output** of the plan in an outreach or educational environment.

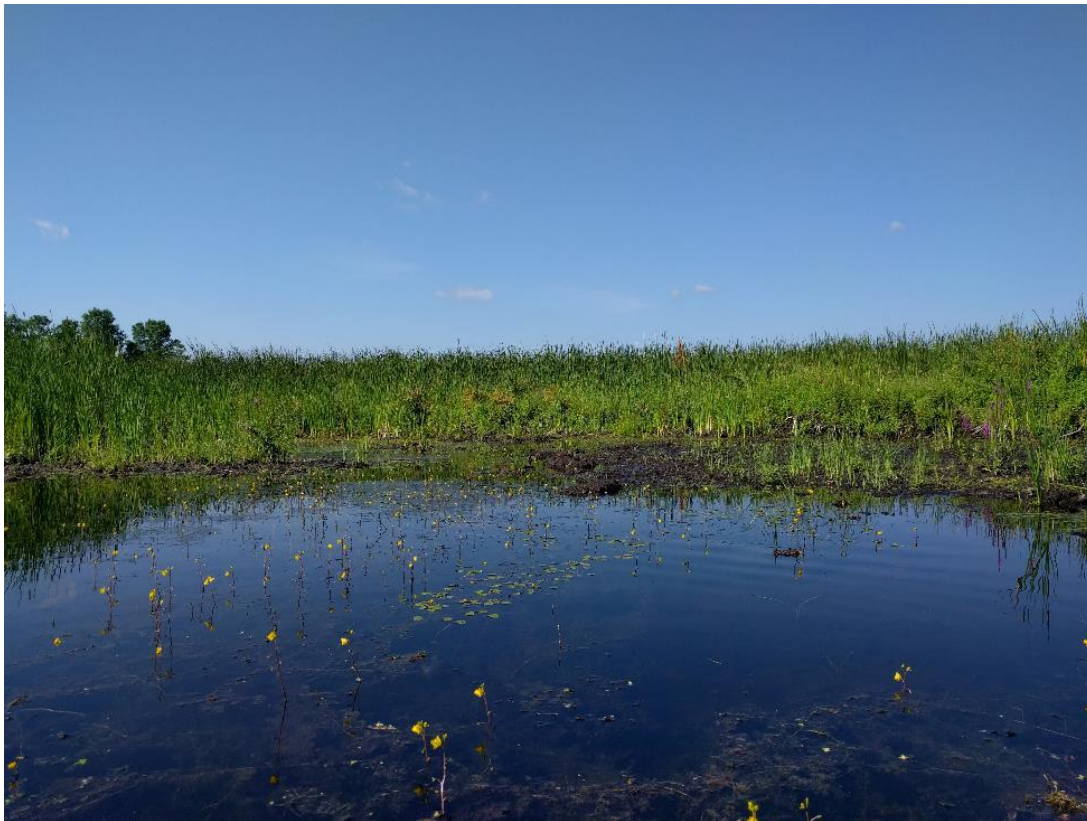
Implementation of the Braddock Bay Ecosystem Restoration project began in winter of 2016 with the excavation of approximately seven acres of channels and potholes within the existing marsh. Excavation began in January and concluded in March of 2016. Once completed, channel and pothole benches and habitat mounds were seeded with native seed mixes. Plugs of native wetland plants were planted in June of 2016. Cattail in the invasive species areas was mechanically removed in late July and treated chemically in late September. Phragmites stands were treated in late September and then removed mechanically in late October. Construction of the barrier beach began in August (Figure 6). Placement of the stone portions of the barrier beach were completed by December 2016. Additional work for 2017 will include sand placement on the barrier beach, installing live stakes and plugs on the barrier beach, additional treatment of cattail and phragmites, and construction of a 2.7 acre of emergent marsh within Braddock Bay.

**Figure 5. Pothole excavated during winter 2016. Photo taken August 8, 2016.**

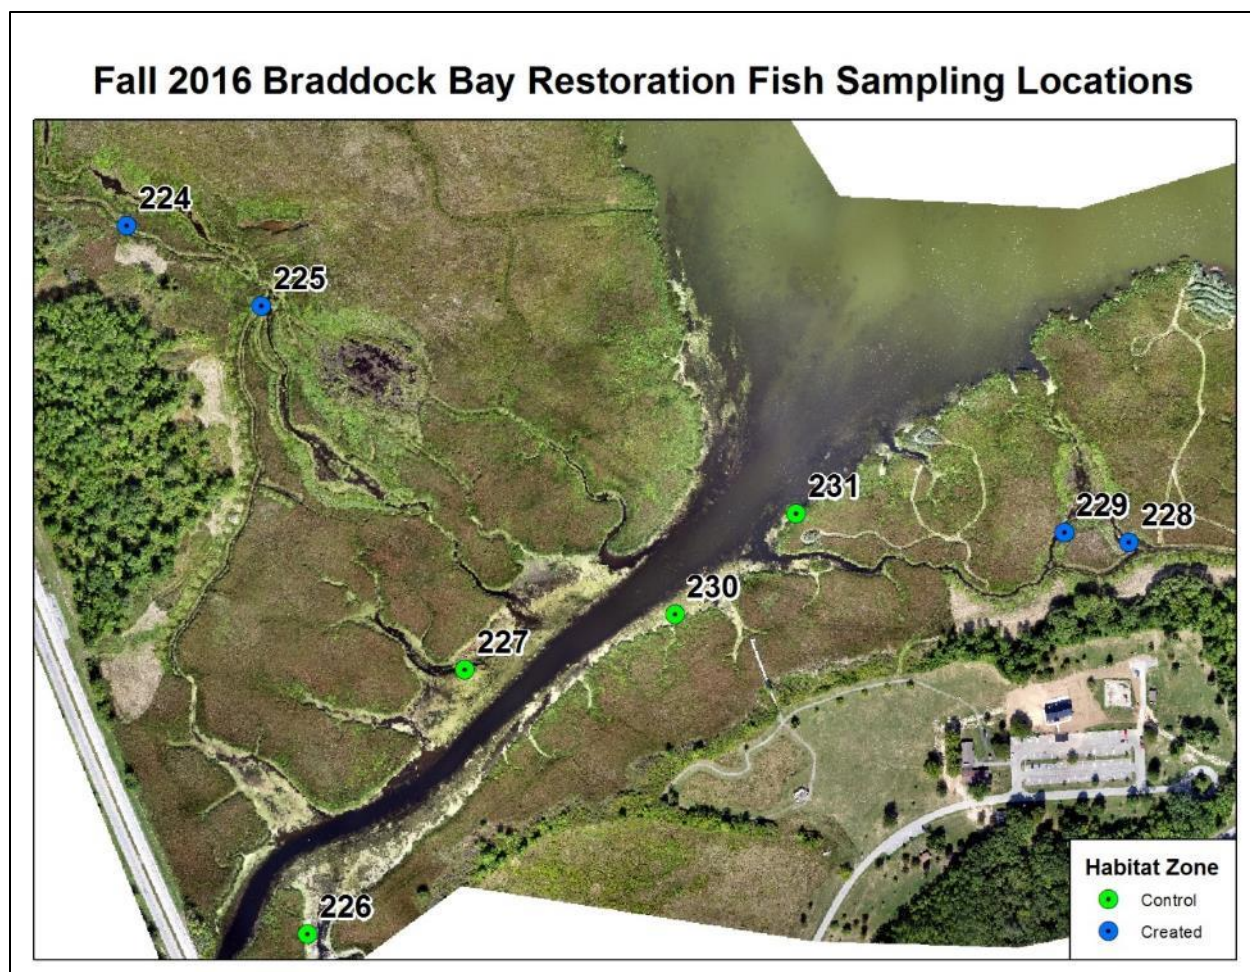
**Fish Surveys** – The fish community in newly-created potholes and previously existing shallow water areas of Braddock Bay were surveyed from October 7<sup>th</sup> to October 16<sup>th</sup> of 2016. Survey crews used both large mesh (6.25mm) and small mesh (2.4mm) nets evenly in both habitats to balance out the biases present in both mesh sizes. Each mesh size was fished for four net-nights in each habitat, for a total of eight net-nights of fishing per habitat and 16 net-nights overall. Figure 10 shows the net locations in the newly-created and control zones. Nets were placed in water between 0.5 and 1.0m deep for approximately 18-24 hours. All species encountered, both fish and non-fish, were identified, aged as either “Young of Year (YOY)” or “Other”, and counted the following morning. All fish were returned back to the water and the net was re-set for the following night. For additional information see Appendix 2.

Figure 10. 2016 Fish Survey Locations
